**Flood Control Project Maintenance
Levee Inspections**
LMA District Cover Sheet
Spring 2015 Levee Inspection Results

Reclamation District No. 1600 Mull

Spring 2015 Levee Inspection Results

Waterway			Bank	Unit Miles
Unit No. 01 Sacramento River			Right	10.46
	Spring (March - May)	Summer (June - August)	(September - November) Fall	Winter (December - February)
Unit Maintenance Rating (Fall Only)				
Date of Inspection	03/24/2015 - 03/24/2015			
DWR Inspector	Jai Lor			
Accompanied By

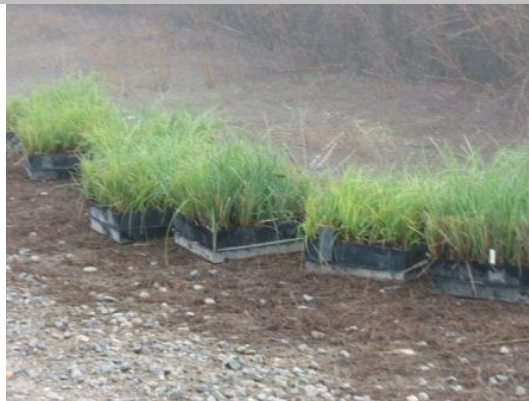
Photo 1 of 2 : SP_2015_RD1600_191_5_20150324_00005.jpg

LM Start	1.40	Rating **	A/W	Issue No.	5
LM End	1.40	Issue Type +	Ma	Location *	WS
Category	Earthen Levee			GPS Latitude/Longitude	
				Start	End
Item	Vegetation			38.694589 °	38.694589 °
				-121.634286 °	-121.634286 °
DWR ID	DWR_RD1600_01_f_2012_5				
Action/Comments					
Environmental Requirements.

Flats of plant material to be planted at the site. Fall 2012

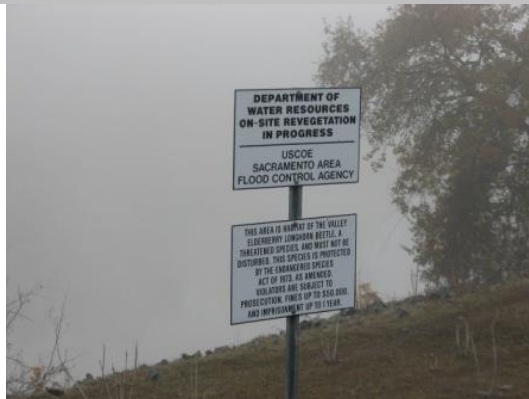
Photo 2 of 2 : SP_2015_RD1600_191_5_20150324_00006.jpg

LM Start	1.40	Rating **	A/W	Issue No.	5 (cont)
LM End	1.40	Issue Type +	Ma	Location *	WS

Revegetation site. Fall 2012.

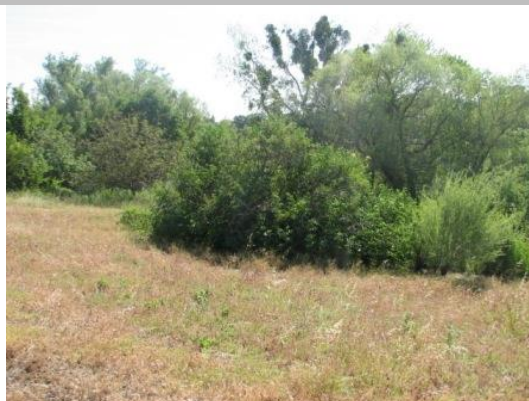
Photo 1 of 2 : SP_2015_RD1600_191_31_20150324_00030.jpg

LM Start	1.72	Rating **	A/W	Issue No.	31
LM End	1.72	Issue Type +	En	Location *	WS
Category	Earthen Levee			GPS Latitude/Longitude	
				Start	End
Item	Vegetation			38.698613 °	38.698613 °
				-121.631710 °	-121.631710 °
DWR ID	DWR_RD1600_01_s_2012_31				
Action/Comments					
Environmental Requirements.

A photo of an Elderberry bush in the area.

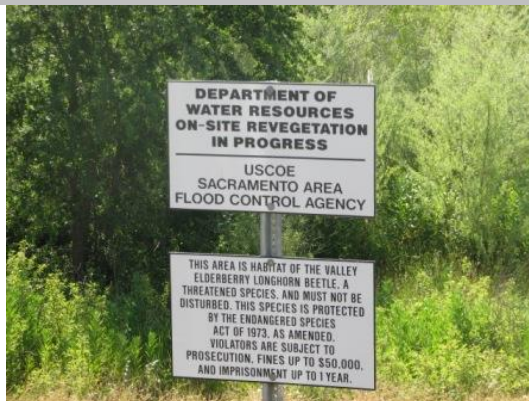
Photo 2 of 2 : SP_2015_RD1600_191_31_20150324_00031.jpg

LM Start	1.72	Rating **	A/W	Issue No.	31 (cont)	
LM End	1.72	Issue Type +	En	Location *	WS	
Category	Earthen Levee			GPS Latitude/Longitude		
				Start		End
Item	Vegetation			38.698613 °		38.698613 °
				-121.631710 °		-121.631710 °
DWR ID	DWR_RD1600_01_s_2012_31					
Action/Comments						
Environmental Requirements.

Revegetation site with the Elderberry Beetle. Photo taken spring 2012.

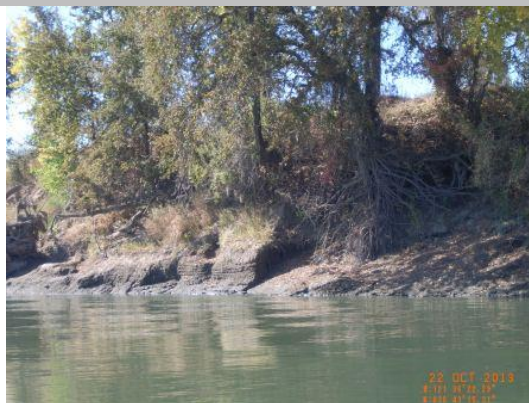
Photo 1 of 1 : SP_2015_RD1600_191_8_20150324_00010.jpg

LM Start	3.58	Rating **	M	Issue No.	8
LM End	3.83	Issue Type +	Ma	Location *	WS
Category	Supplemental			GPS Latitude/Longitude	
				Start	End
Item	USACE Erosion Survey			38.717770 °	38.721351 °
				-121.607423 °	-121.606414 °
DWR ID	DWR_RD1600_01_f_2014_8				
Action/Comments					
Inspector Comments: 1997 - Steep high bank. 2005 - Some small pockets in the low toe near the waterline. 2006 - Minor slope clearing. 2010 - Minor new erosion. 2011 - Multiple trees have fallen since last year. Some other trees look ready to fall. Significant new erosion since last year. 2012 - Minor new erosion. 2013: Minor new erosion. [2013 Site ID: SAC_74-4_R]

USACE 2013 Photo #1

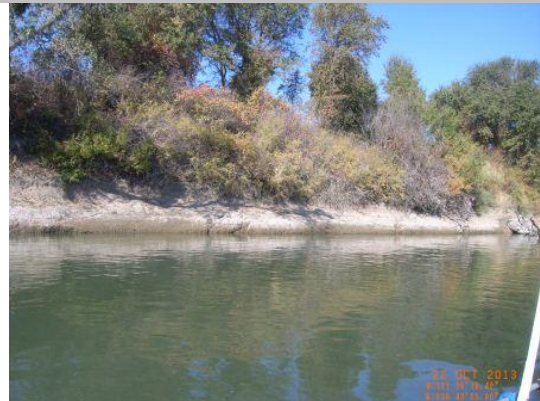
Photo 1 of 1 : SP_2015_RD1600_191_10_20150324_00011.jpg

LM Start	4.21	Rating **	M	Issue No.	10
LM End	4.86	Issue Type +	Ma	Location *	WS
Category	Supplemental			GPS Latitude/Longitude	
				Start	End
Item	USACE Erosion Survey			38.728684 °	38.736110 °
				-121.605844 °	-121.604153 °
DWR ID	DWR_RD1600_01_f _ 2014_10				
Action/Comments					
Inspector Comments: 1997 - Very steep bank. 2005 - Lots of small trees down along the bank at the upstream end. 2006 - Minor new erosion, but slow. 2010 - Almost all of the roots are exposed on the trees, appears ready to fall. 2011 - New erosion and tree popouts. 2012 - Site has become overgrown with vegetation, making it hard to observe. 2013: No observed changes. [2013 Site ID: SAC_75-3_R]

USACE 2013 Photo #1

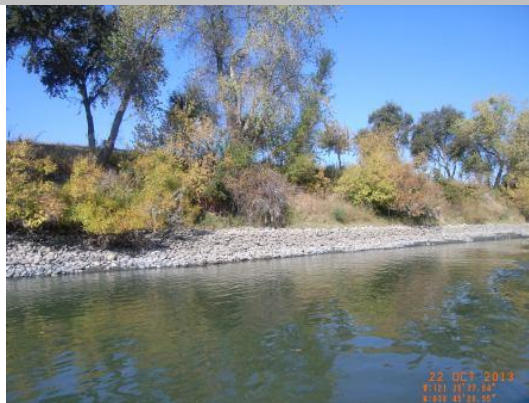
Photo 1 of 1 : SP_2015_RD1600_191_11_20150324_00012.jpg

LM Start	6.30	Rating **	M	Issue No.	11
LM End	6.36	Issue Type +	Ma	Location *	WS
Category	Supplemental			GPS Latitude/Longitude	
				Start	End
Item	USACE Erosion Survey			38.755246 °	38.756186 °
				-121.594206 °	-121.594024 °
DWR ID	DWR_RD1600_01_f_2014_11				
Action/Comments					
Inspector Comments: 2011 - Large vertical eroded face from a rotational failure just below pump. 2013: No observed changes. [2013 Site ID: SAC_77-0_R]

USACE 2013 Photo #1

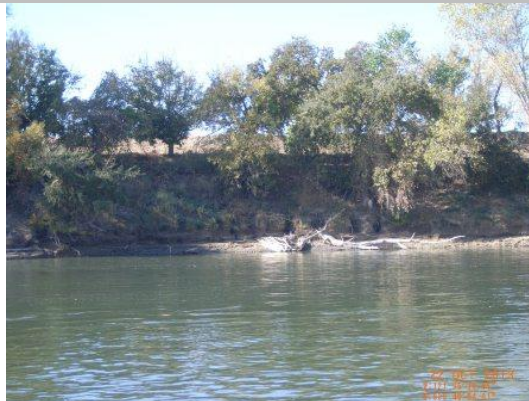
Photo 1 of 1 : SP_2015_RD1600_191_12_20150324_00013.jpg

LM Start	6.95	Rating **	M	Issue No.	12
LM End	6.98	Issue Type +	Ma	Location *	WS
Category	Supplemental			GPS Latitude/Longitude	
				Start	End
Item	USACE Erosion Survey			38.764801 °	38.765219 °
				-121.594926 °	-121.595049 °
DWR ID	DWR_RD1600_01_f_2014_12				
Action/Comments					
Inspector Comments: 2006 - Eddy scour off end of rock causing erosion and scour hole near levee. Sandy silt bank with rock on upstream end. 2010 - Trees are leaning more, minor new erosion. 2011 - Many of the tree roots have scoured out and trees look ready to fall. 2013: No observed changes. [2013 Site ID: SAC_77-7_R]

USACE 2013 Photo #1

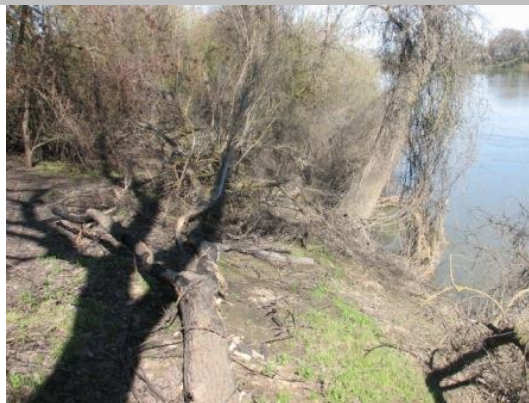
Photo 1 of 2 : SP_2015_RD1600_191_20_20150324_00018.jpg

LM Start	7.09	Rating **	M	Issue No.	20
LM End	7.09	Issue Type +	Ma	Location *	WS
Category	Earthen Levee			GPS Latitude/Longitude	
				Start	End
Item	Erosion / Bank Caving			38.766505 °	38.766505 °
				-121.596214 °	-121.596214 °
DWR ID	DWR_RD1600_01_s _ 2012_20				
Action/Comments					
Note and monitor erosion site.

This another view of the site.
